## **2. SETTING**

### **2.1 Regional Setting**

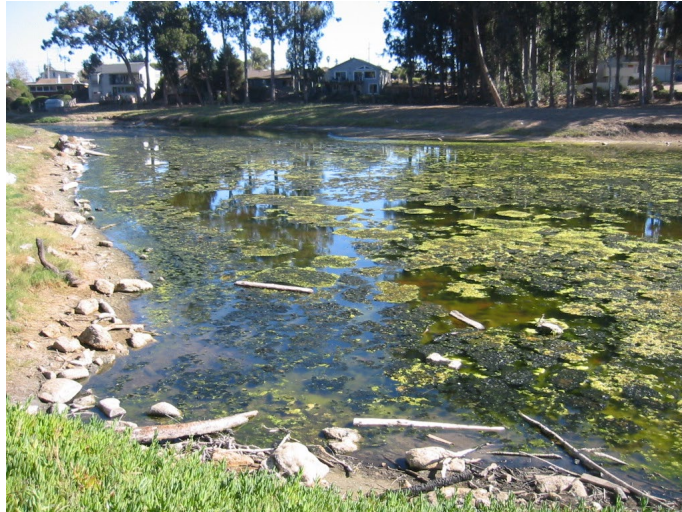
are low occurring typically in later spring. The bar closure limits the interaction between the lagoon and the ocean. During this period, extensive algal blooms were observed on the surface of the lagoon, as shown in Figure 3.7. Figures 3.8 and 3.9 show Moran Lake when the ephemeral bar has formed across the inlet and sand has accumulated inside the box culvert.

**Figure 3.7. Algal Blooms on the Surface of Moran Lake when the Lagoon is Non-Stratified with Little or No Flow from Freshwater or Tidal Inputs – *October 28, 2003***

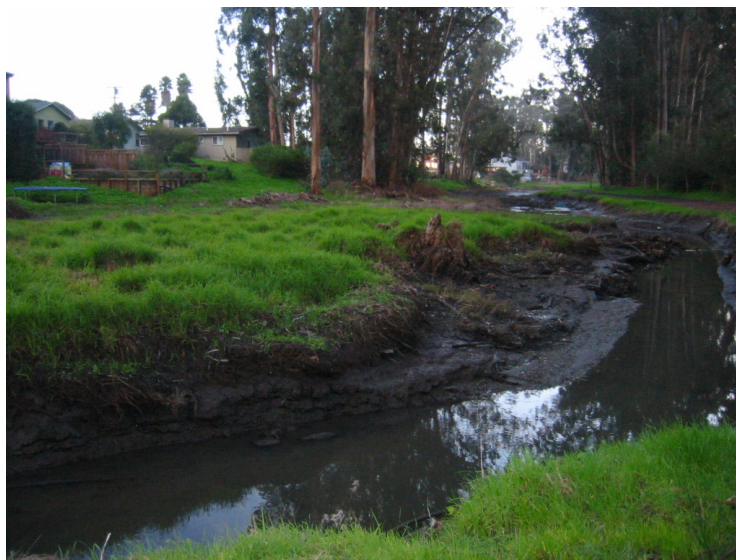
**Increased Bank Erosion and Sedimentation.** The second change in stream hydrology is an increased frequency of erosive bankfull and sub-bankfull floods. A bankfull flow occurs once every 2 to 2.5 years and has the greatest influence on channel forming features, such as bank height and location and mid-channel bars. The frequency of a bankfull or sub-bank full flow increases in an urban watershed, causing high energy flows that disrupt the channel equilibrium, accelerating bank and channel erosion and sedimentation in the downstream stream and lagoon. Increased bank erosion can also result in costly damage and/or loss of private and public property and infrastructure. Figure 3.13 shows active bank erosion occurring in the upper stream reach of Moran Lake.

**Figure 3.13. Channel Erosion in Upper Reach of Moran Lake**

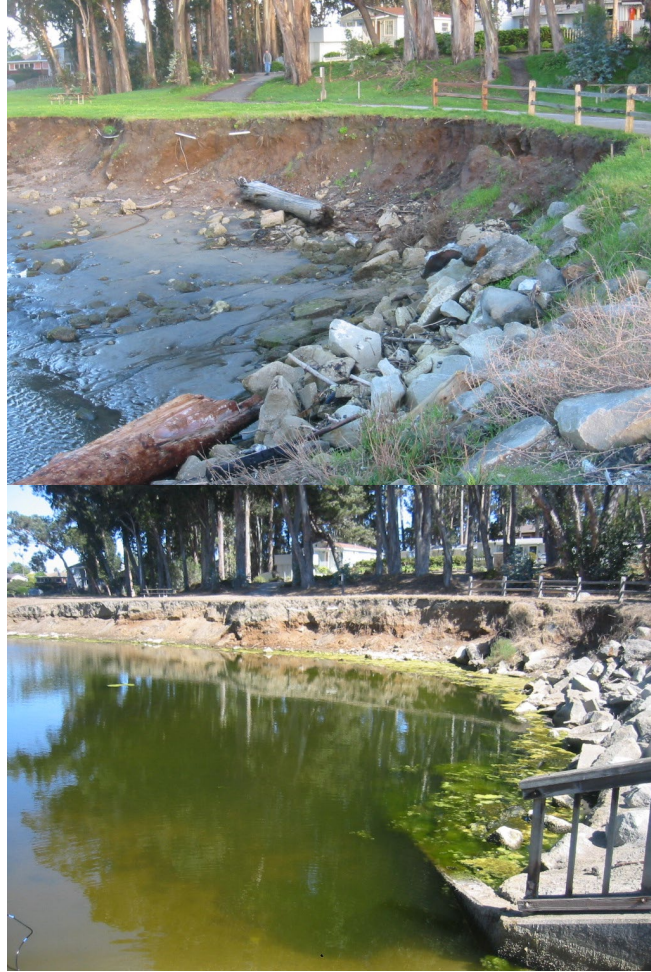
Due to urban development adjacent to the lake wetlands that once likely existed along the edges of Moran Lake have been destroyed. Concurrent with the removal or alteration of fringe wetlands, diminished vegetation and increased flows from a mostly impervious watershed have resulted in failing banks at some locations along the shore of the lagoon. The most notable failure has occurred on the lower east lagoon bankslope. Figure 5.7 shows the failing bank and its proximity to a frequently accessed bike trail. (A portion of the slope near the lagoon outlet has been reinforced with riprap.)

**Figure 5.7. Eroding Bank on the Eastern Shore of Moran Lake**  
**(Photos taken on September 11, 2003 (lower) and February 2, 2004)**

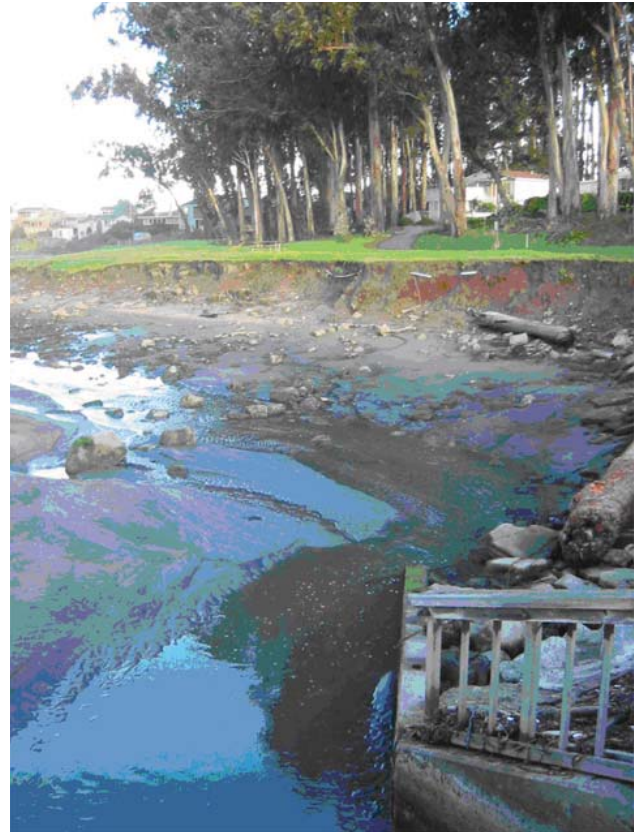
Eroding Bank on Eastern Shore of Moran Lake (Figure 21)

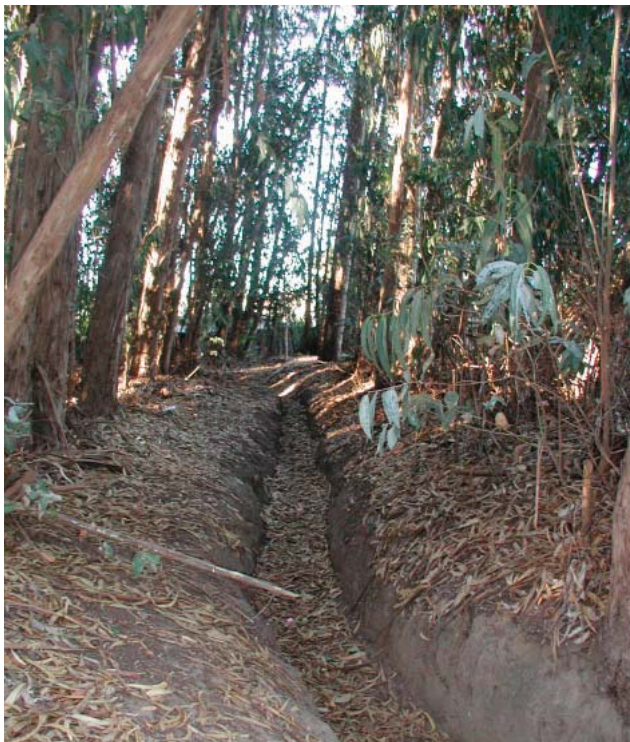
Existing Drainage Channel at D. A. Porath Sanitation Facility (Figure 23)

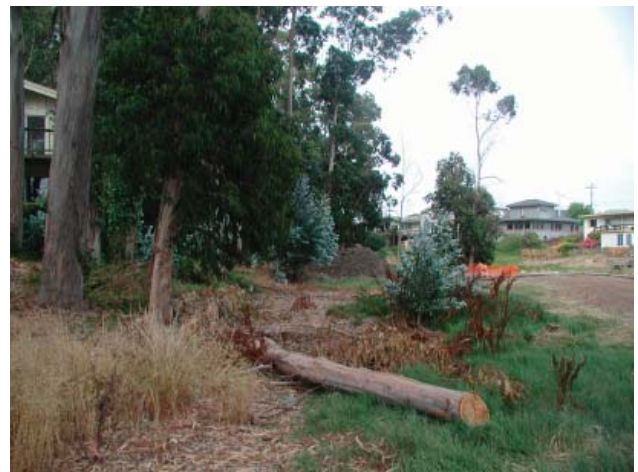
Although blue-gum eucalyptus are somewhat tolerant of saturated soil conditions, the excessive water build-up has in some cases led to a weakening of the soil structure and subsequent loss of trees from wind-throw due to soil and root failure (Figure 24). The problem is compounded by the interdependency of wind protection among the densely planted trees, since with each tree lost, the remaining trees become less protected from wind. Altering this pattern of tree loss is of paramount importance both for public safety reasons and for preservation of the monarch butterfly wintering habitat.

Saturated Area Causing Tree Failure (Figure 24)

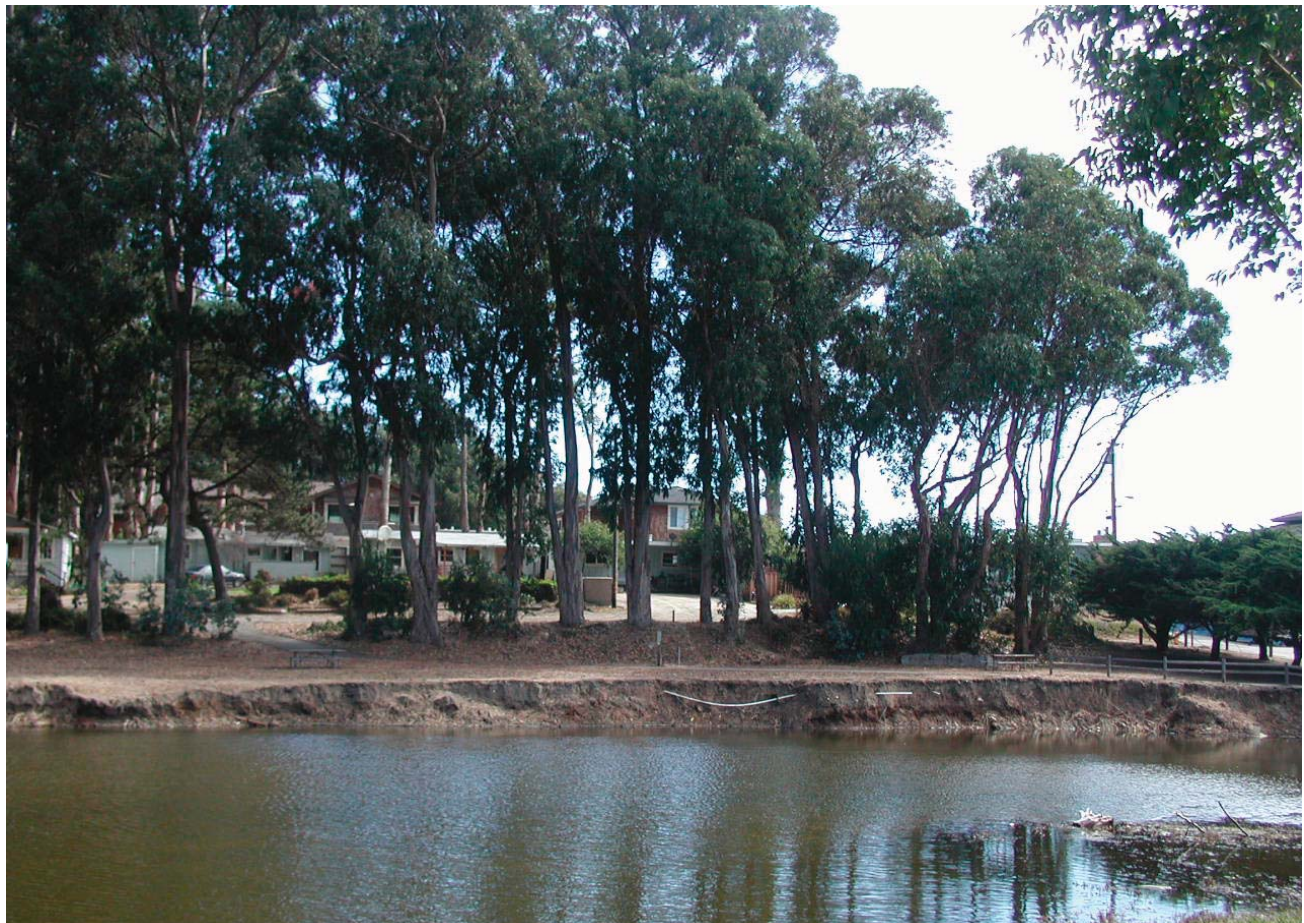
Existing Bicycle Path Compromised by Erosion (Figure 39)

Existing Conditions of Bank at Bicycle Path (Figure 40)

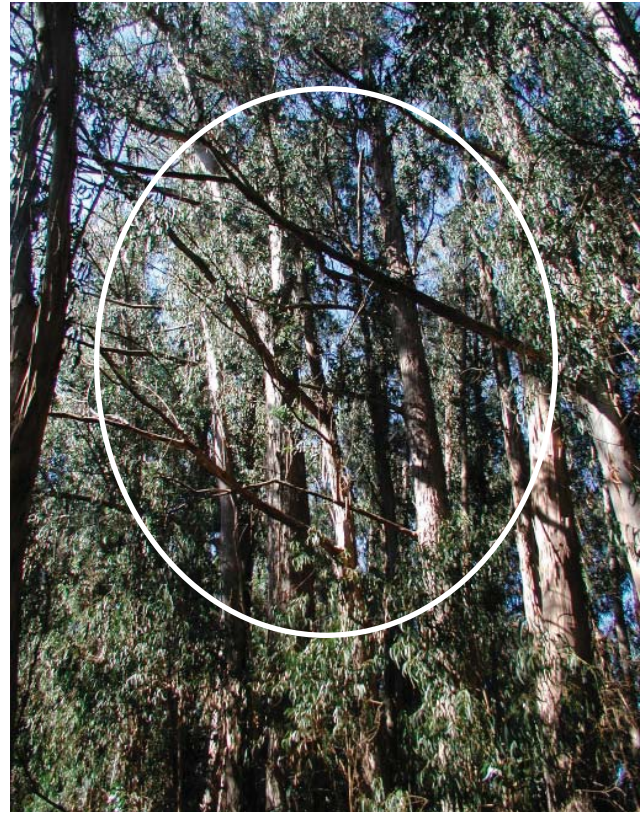
Dead or Dying Branches to be Removed (Figure 61)

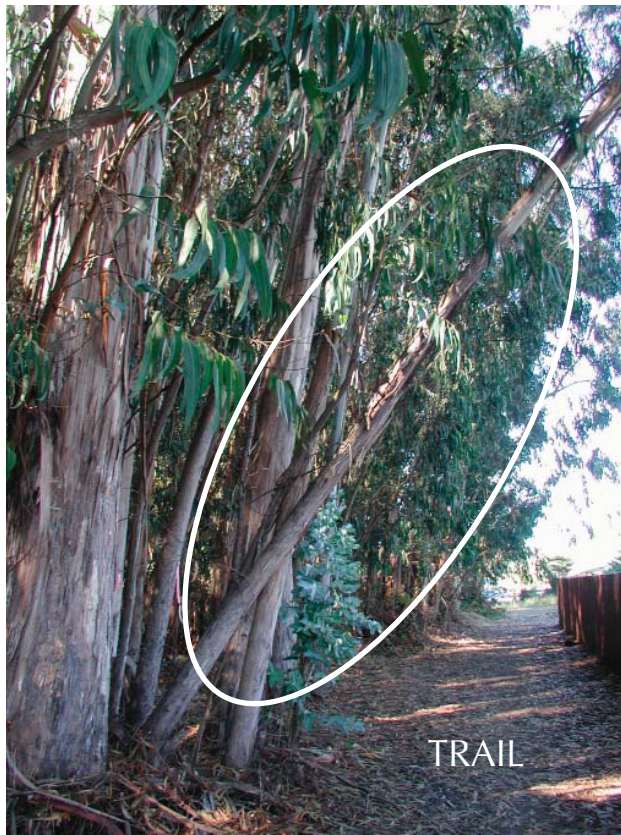
Branch to be Removed (Figure 65)

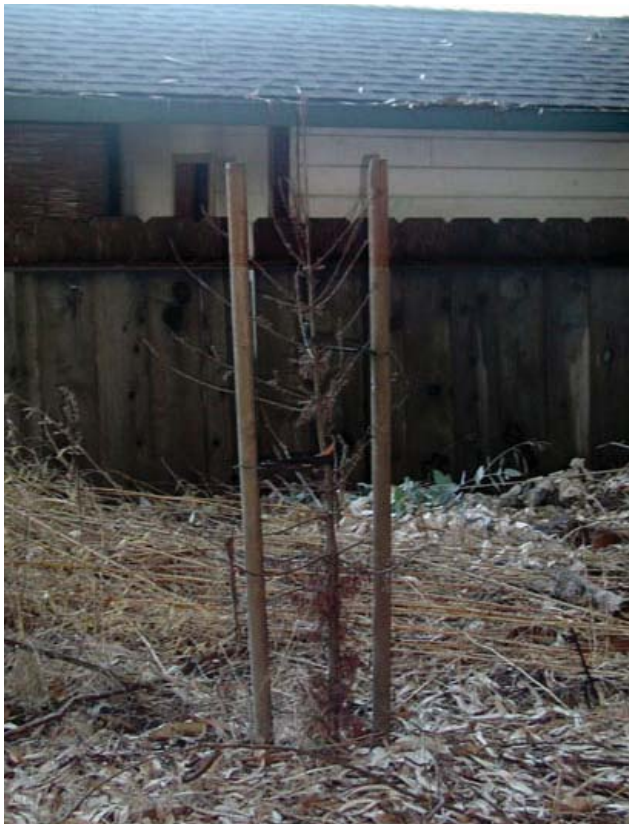
Recently Planted Coast Redwood Tree - Dead (Figure 71)

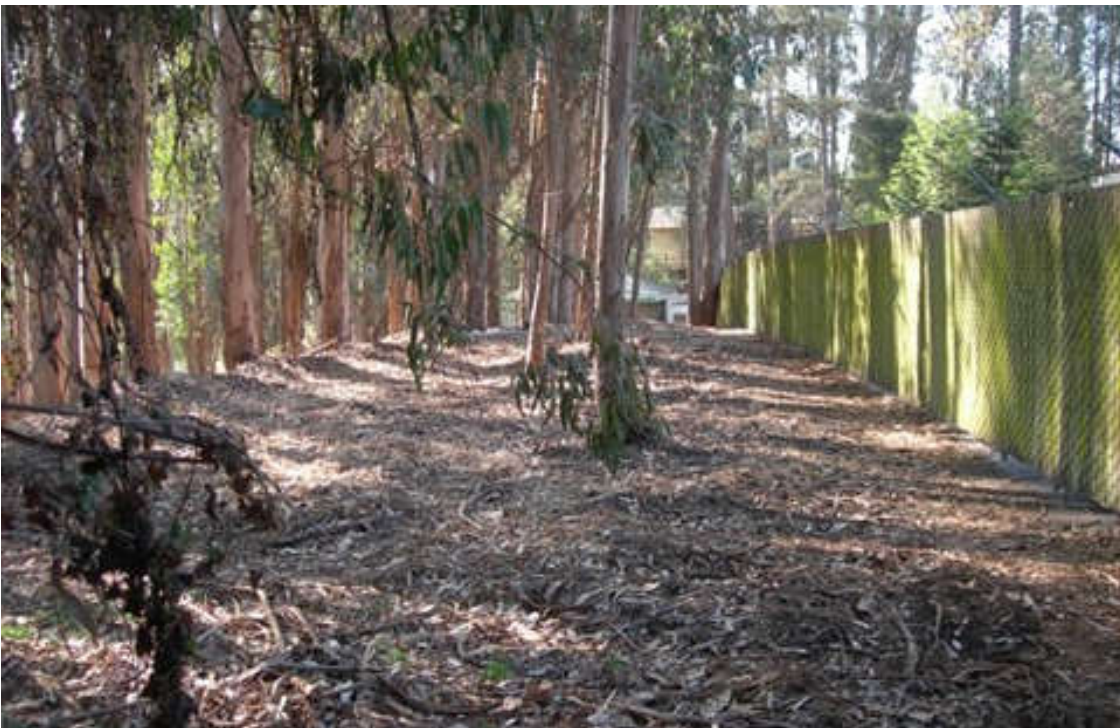
**Photograph 2.** Gap of mid-canopy trees and wind protection along the eastern side of the Sanitation Facility. Plant with mid-canopy replacement trees, Monterey cypress in this area.

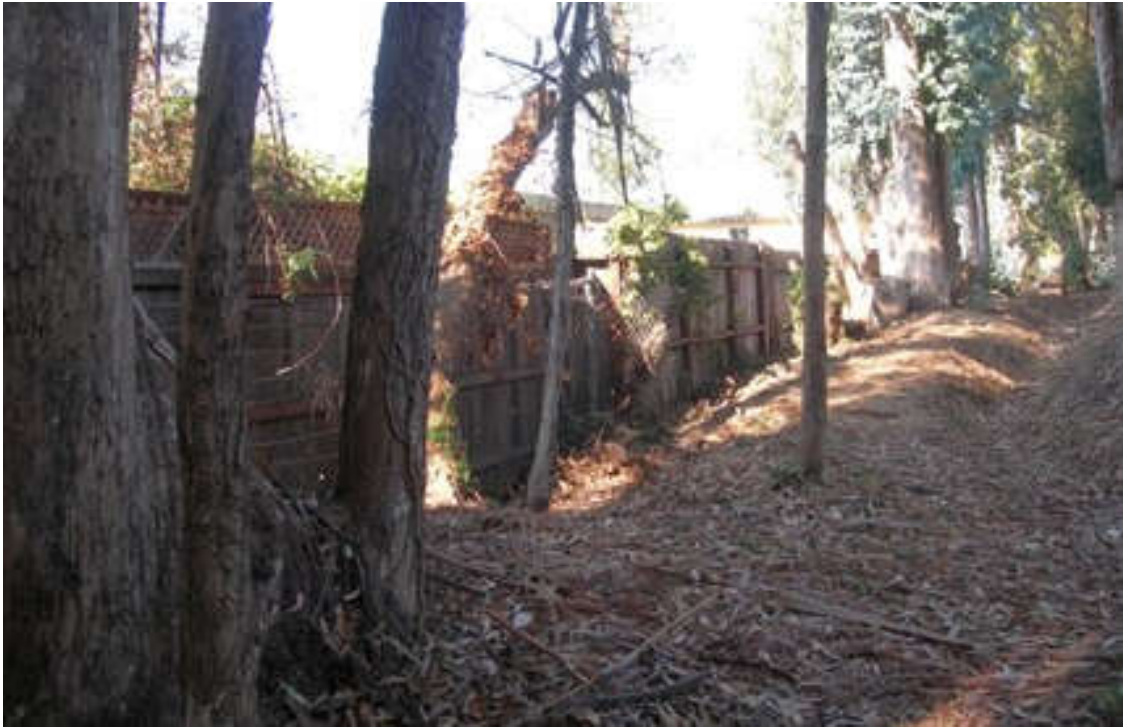
**Photograph 3.** Gap along the southern boundary of the windbreak, along the Sanitation Facility boundary Plant with mid-canopy replacement tree, Monterey cypress.

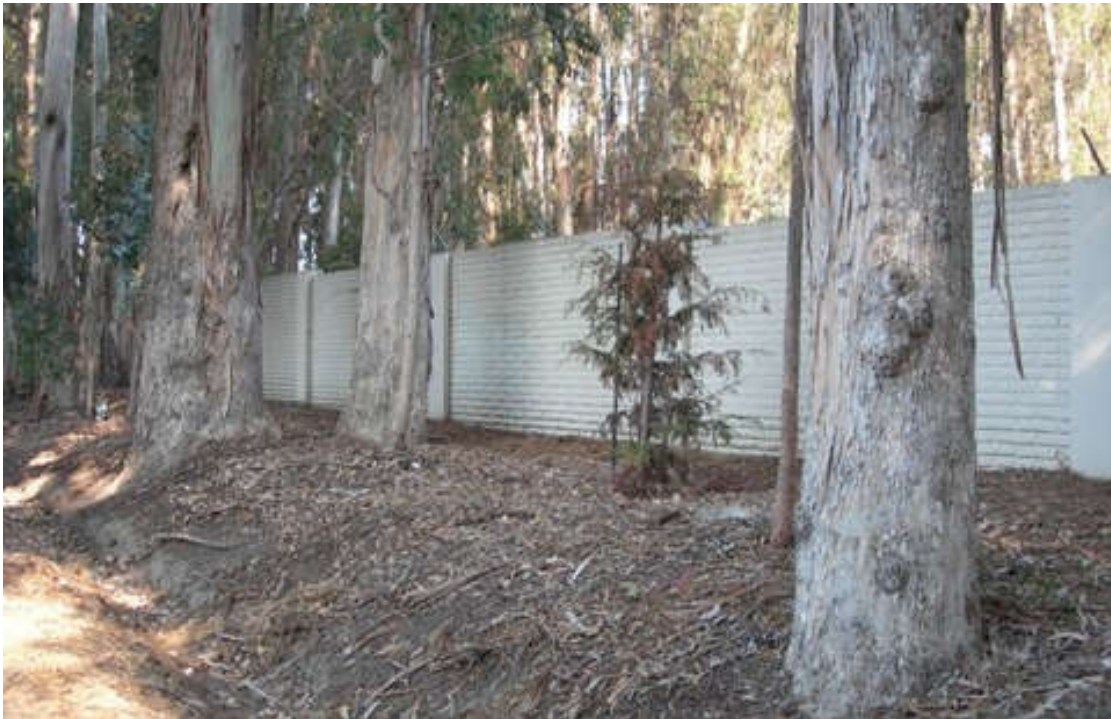
**Photograph 4.** Dead redwood tree planted as a replacement but did not survive. Remove and replant with red ironbark or blue gum eucalyptus replacement tree.

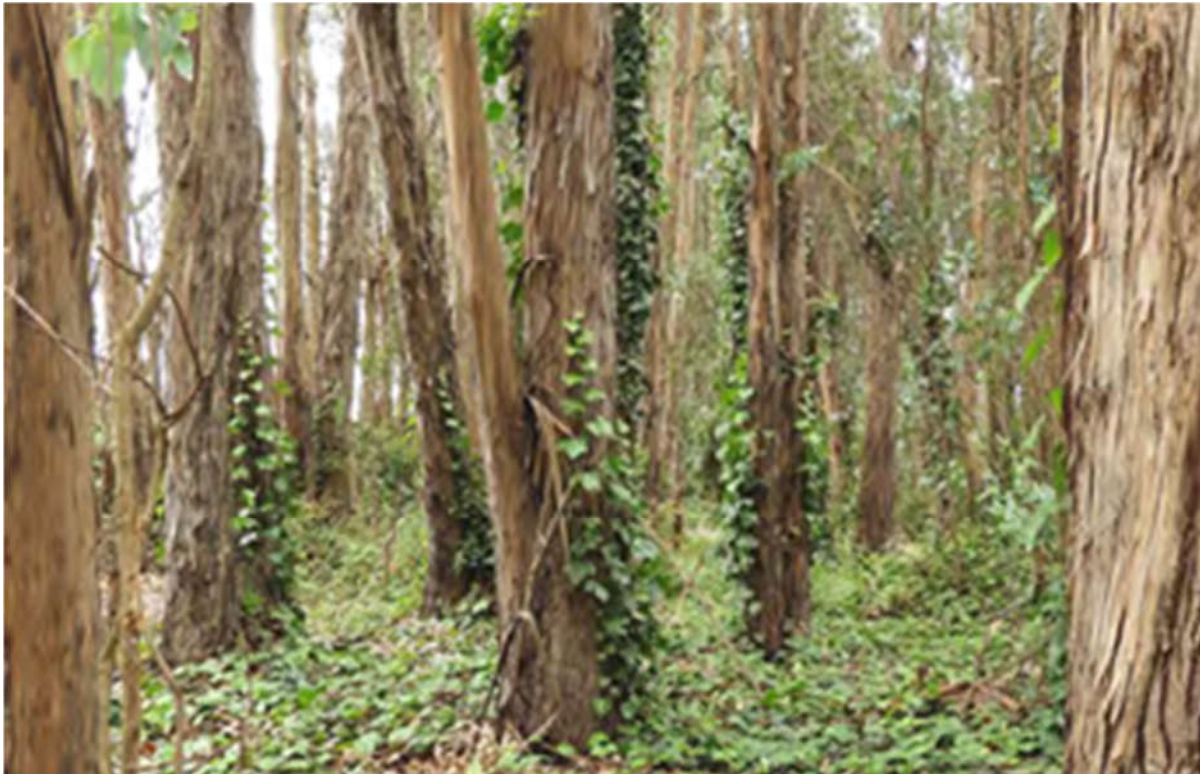
**Photograph 5.** English ivy that will be managed to keep it from invading the tree canopies.
