This document provides the findings of a Biological Resources Assessment prepared by Rincon Consultants, Inc. for the Moran Lake County Park Improvement Project (Project). This report documents existing conditions at the Project site and provides an assessment of potential impacts to sensitive biological resources based upon proposed Project plans.

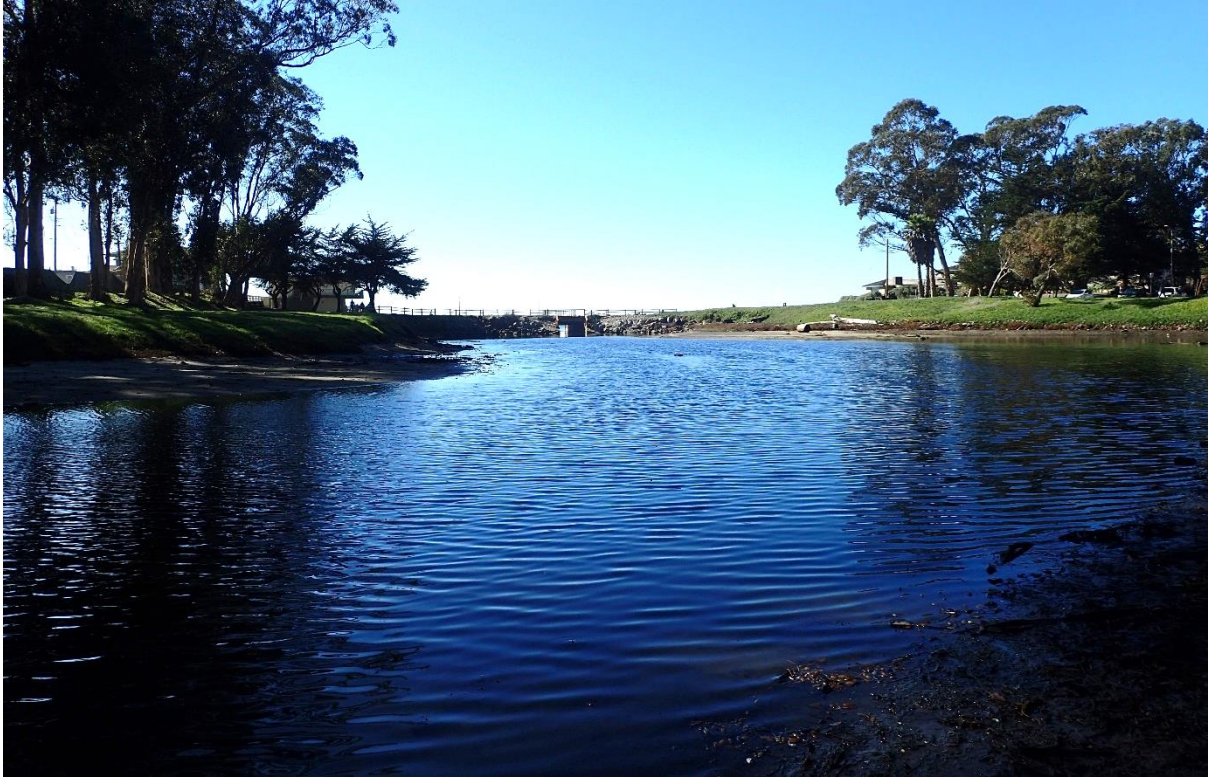
**Photograph 1.** View of the southern extent of Moran Lagoon and the box culvert beneath East Cliff Drive, facing southwest. November 11, 2021.

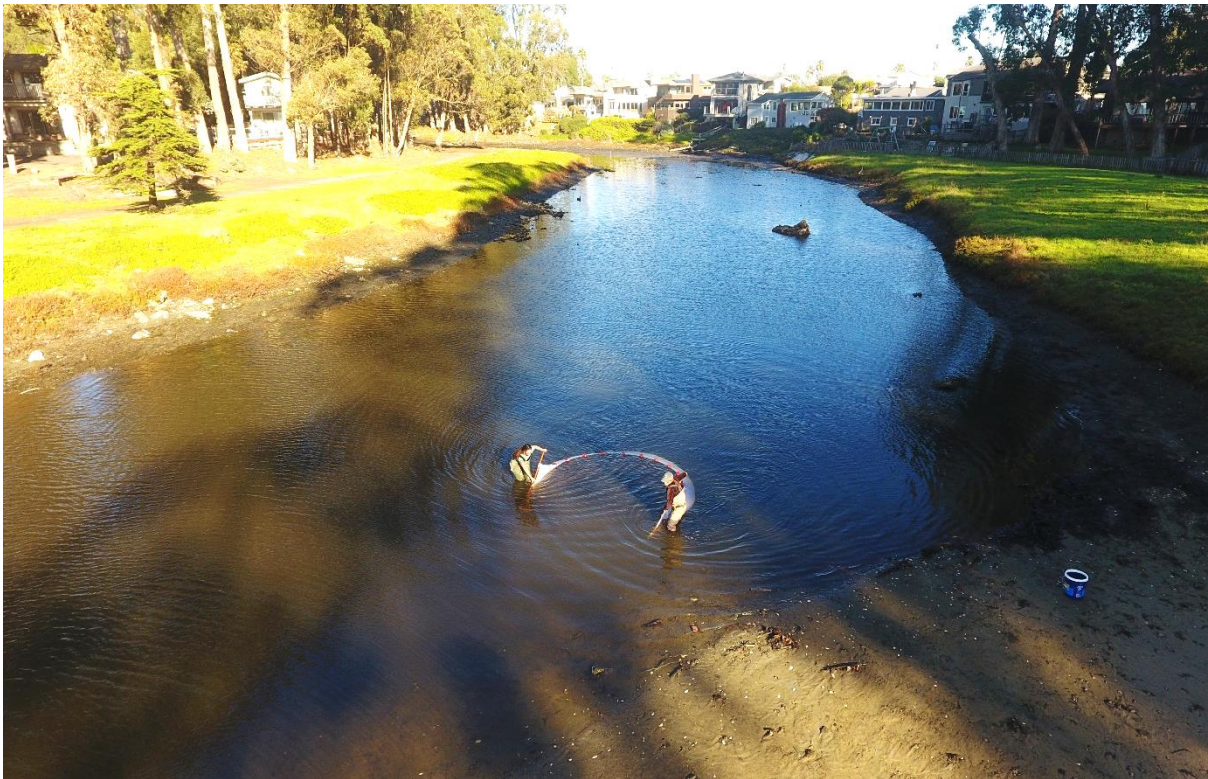
**Photograph 4.** View of Rincon biologists utilizing a brailed seine to survey aquatic species within Moran Lagoon on November 11, 2021. Photo taken facing northeast.

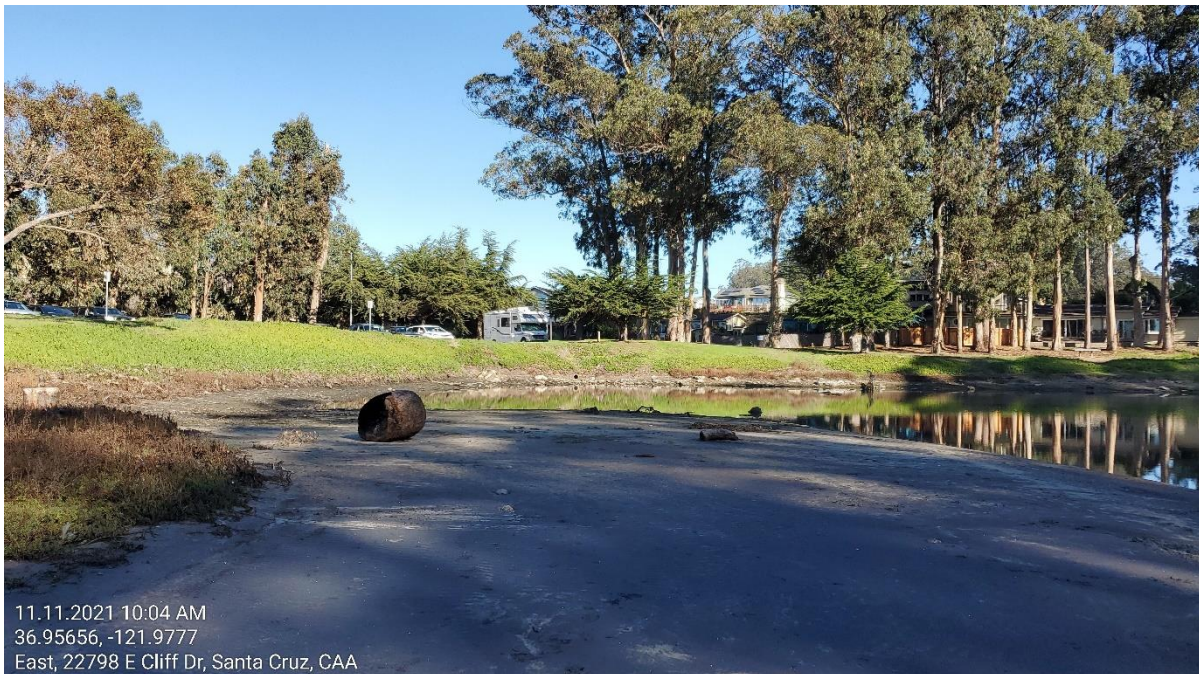
**Photograph 5.** View of the southern extent of Moran Lagoon and surrounding brackish wetland habitat, facing west. The fringe of native pickleweed mats can be seen below the lagoon ordinary high water mark, while invasive iceplant mats can be seen above the pickleweed mats. November 11, 2021.

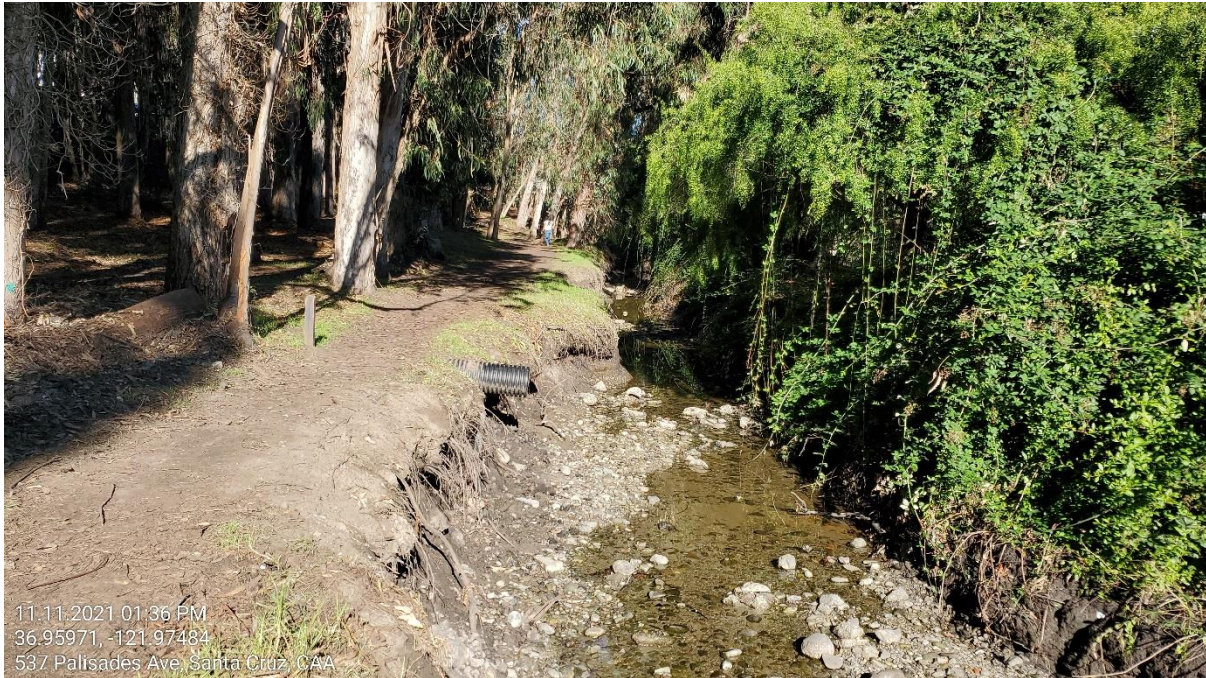
**Photograph 7.** View of Moran Creek and surrounding invasive vegetation, facing northwest. The creek conveys stormwater runoff into the northern portion of Moran Lagoon. November 11, 2021.

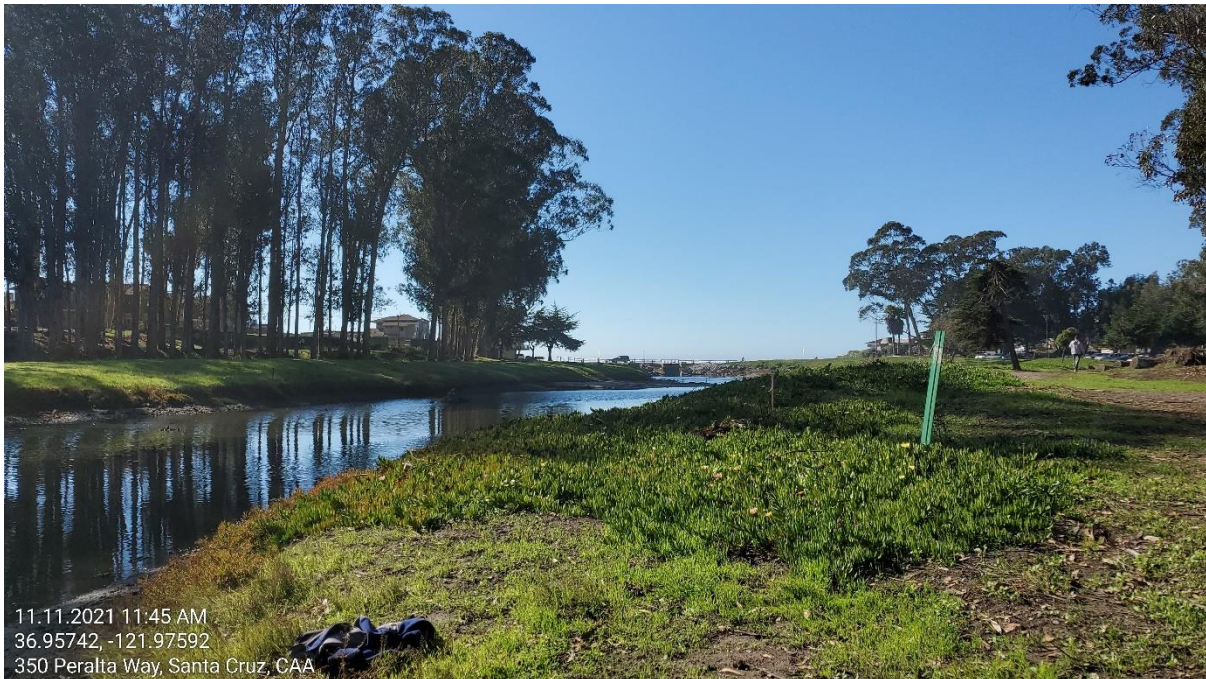
**Photograph 9.** View of pickleweed mats at the edge of Moran Lagoon and ice plant mats growing just upslope of the lagoon. Photo taken facing southeast. November 11, 2021.

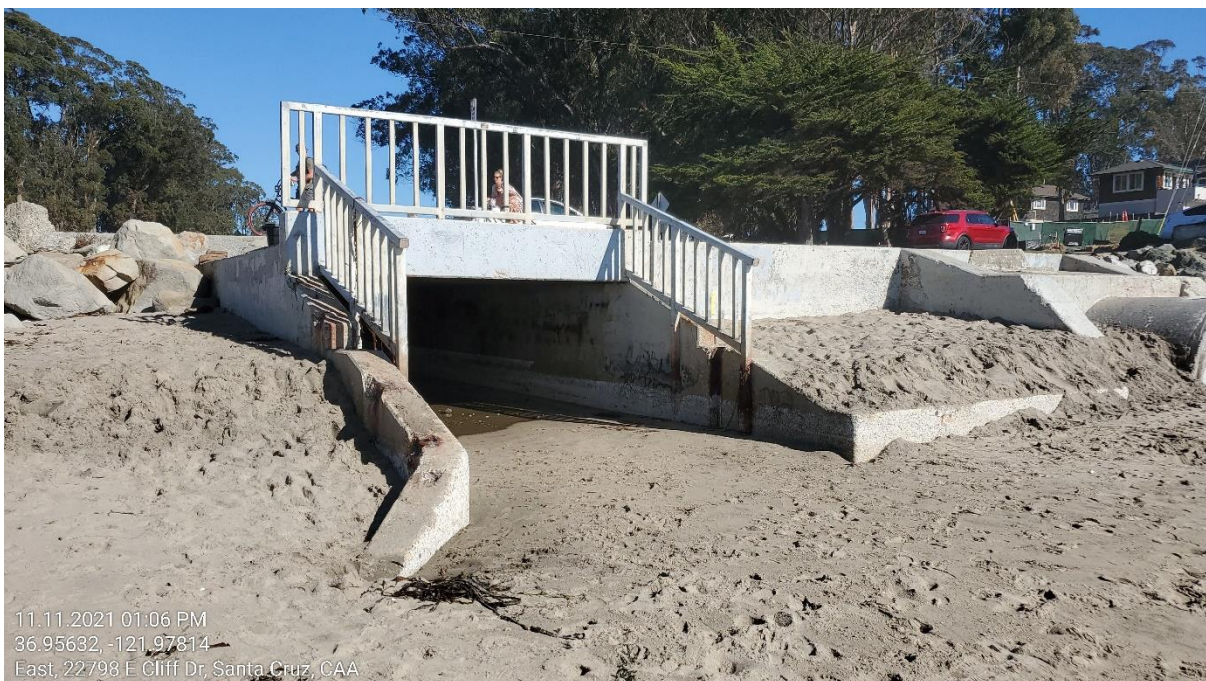
**Photograph 10.** View of Moran Lake Beach and the box culvert beneath East Cliff Drive, facing northeast. November 11, 2021.

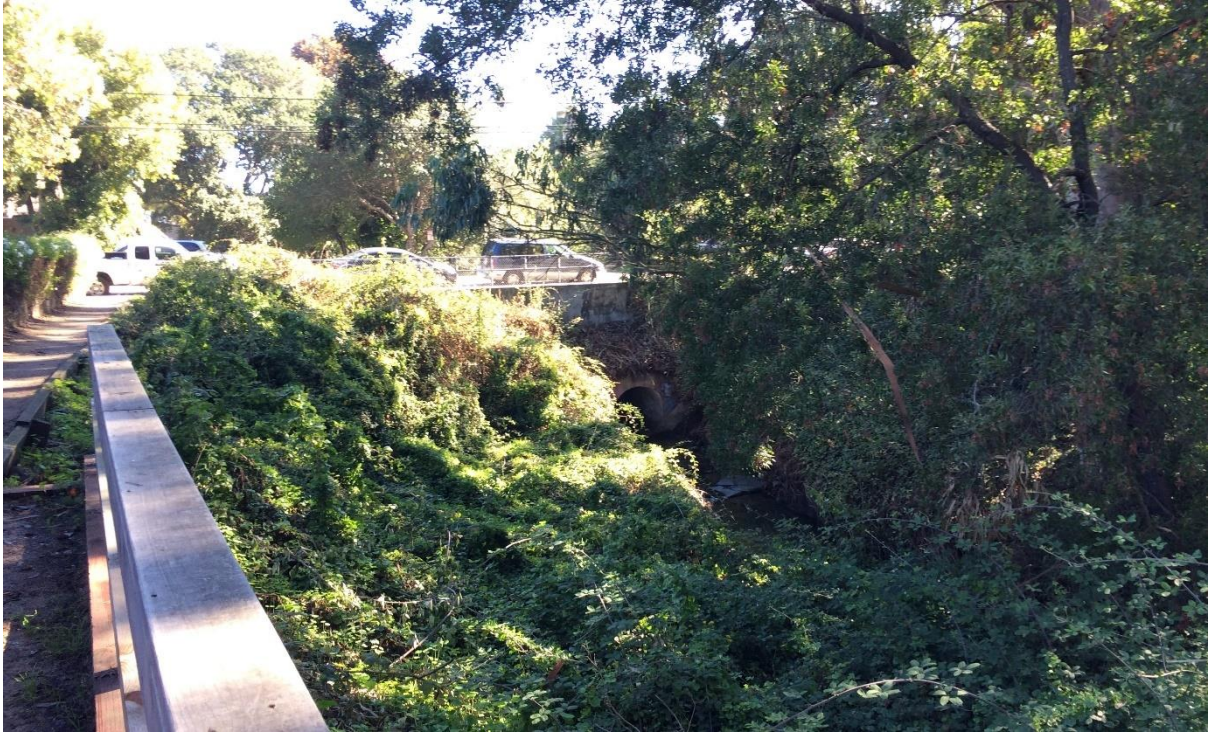
**Photograph 13.** View of disturbed riparian scrub habitat surrounding Moran Creek, facing east. Moran Creek flows through a culvert beneath Thirtieth Avenue, at the northeastern boundary of Project Area, and then flows into Moran Lagoon. November 11, 2021.

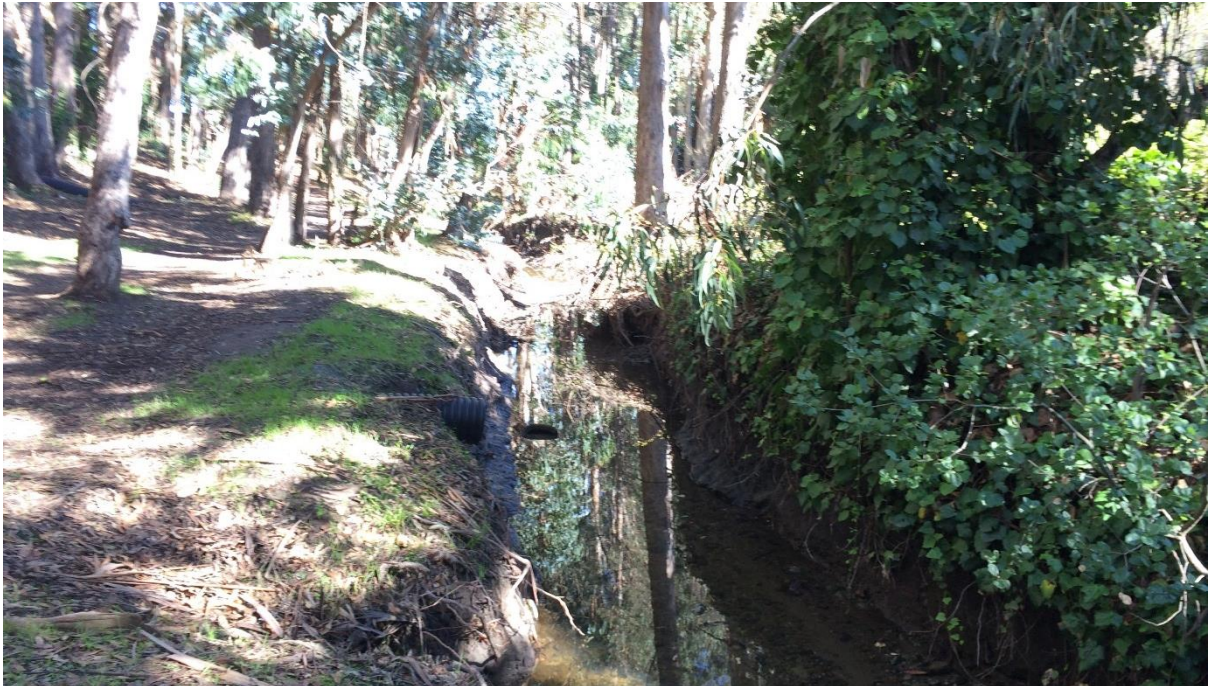
**Photograph 14.** View of invasive woody vine species and eucalyptus groves growing around the eroded banks of the lagoon inlet in the northeastern portion of the Project Area, facing northeast. November 11, 2021.
