## **2. SETTING**

### **2.1 Regional Setting**

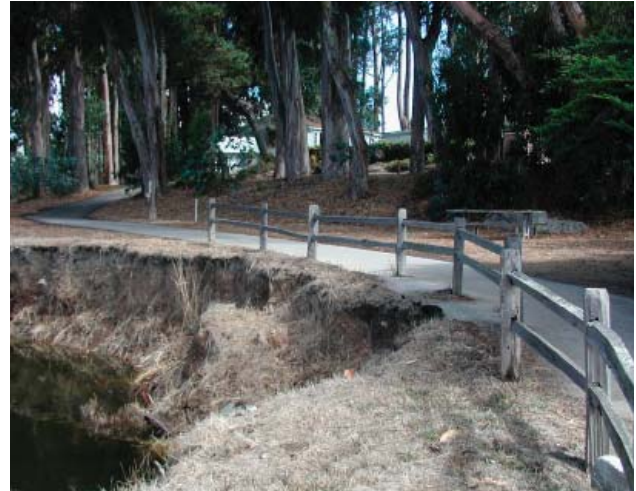
Undertaking a bank stabilization project is important to protect the bicycle path and to reduce further erosion, restore the bank to a more natural configuration and to restore habitat value to the disturbed area.

Existing Bicycle Path Compromised by Erosion (Figure 39)

The existing steep bank should be re-graded from a 2.5:1 to 3:1 slope and be planted with native brackish wetland species. The upper bank should be planted with salt tolerant upland herb and shrub species with the upland flat planted with scattered trees, herbs, and grasses. This design would have the benefits of creating additional wildlife habitat while reducing or eliminating the current rate of bank erosion. In order to protect the bicycle path and adjacent upland, the restored bank may need to be rebuilt in a westerly direction recapturing the bank lost to erosion.

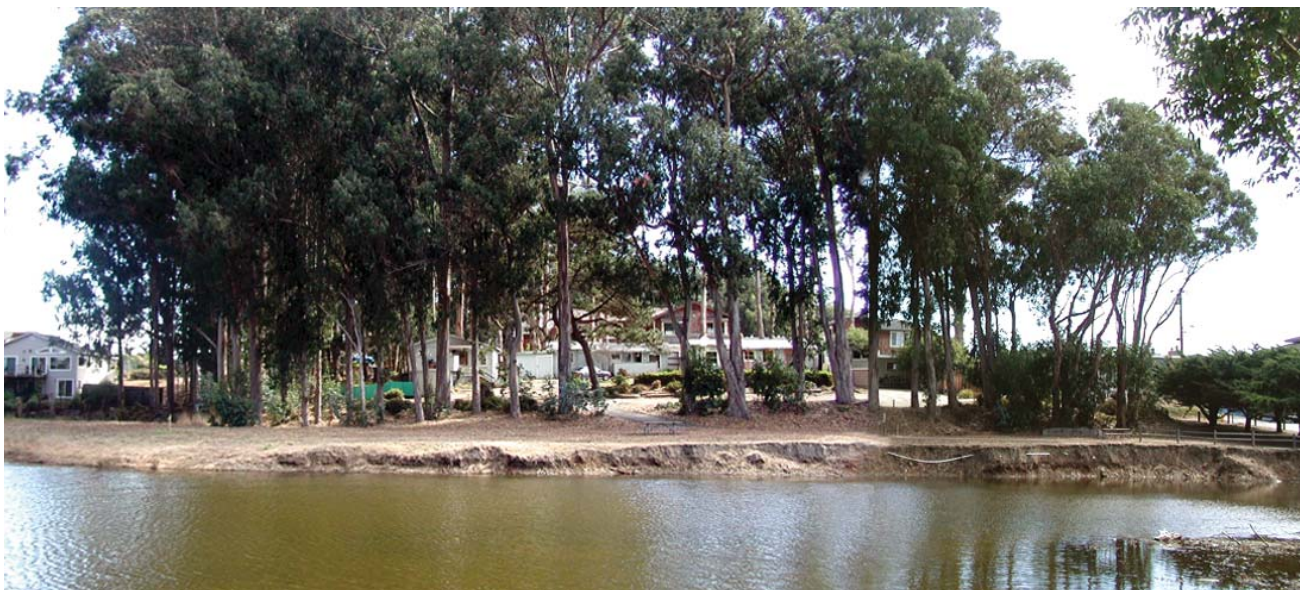
Existing Conditions at Southeast Grove and Moran Way Windrow (Figure 42)

The stability of this wind barrier could be improved by planting salt tolerant eucalyptus (e.g., swamp mahogany, *Eucalyptus robustus*) on the flood plain along the northern edge of the windrow trees (Figure 41). Other tall evergreen species (e.g., Sydney blue gum, *Eucalyptus saligna*) would also be appropriate; however, wind-blown salt-spray and salt concentrations in soil and ground water in this area are likely to limit the survival of many otherwise suitable species (e.g., coast redwood, alder and willow).

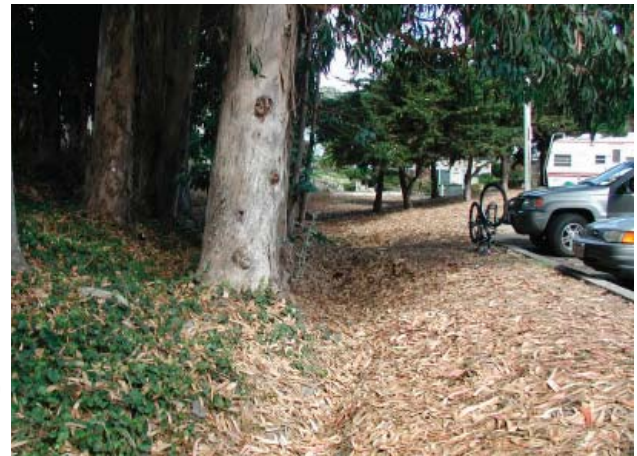
Existing Drainage Pattern at Base of Trees (Figure 49)

- **Improve and maintain existing drainage**
- **Monitor for selective pruning of Eucalyptus**

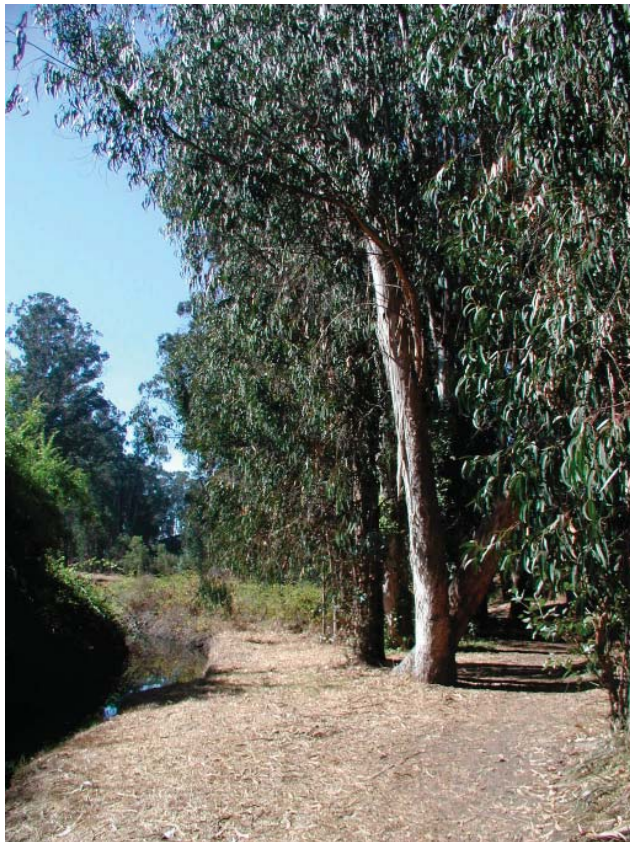
The South Creekside area is critical habitat for the butterflies. There is a public access trail that is heavily used and presents liability issues with the trees. There are several trees of poor structure and overhanging limbs that are a threat to public safety (Figure 61). However, they are part of an important dynamic of the butterfly habitat. New trees of better structure should be planted in open areas to allow future pruning and/or removal of the unsafe trees and will help replace the windbreak lost after trees were removed in 1998-1999.

Existing Conditions at South Creekside Area (Before)  
(Figure 60)

- Prune selective branches that are of particular danger (20 feet long or more).
- Exotic understory nectar species shall be controlled and selectively removed as replacement nectar plants demonstrate that they are providing the food supply necessary for overwintering monarchs.
- Plant new trees where sunlight and open space permit planting. Refer to Figure 62 for approximate locations and species.

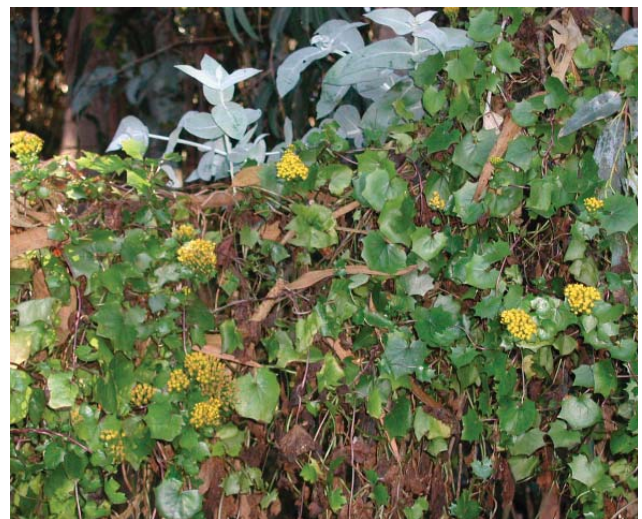
Cape Ivy Growing in Eucalyptus Tree to Remain (Figure 66)

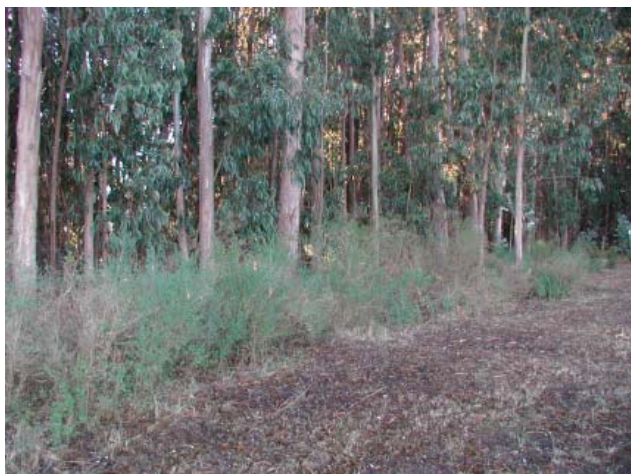
Removal of exotic understory species (e.g. French broom) is acceptable in these areas, as butterflies do not seek nectar in this part of the forest (Figure 69).

Existing French Broom to be Removed (Figure 69)

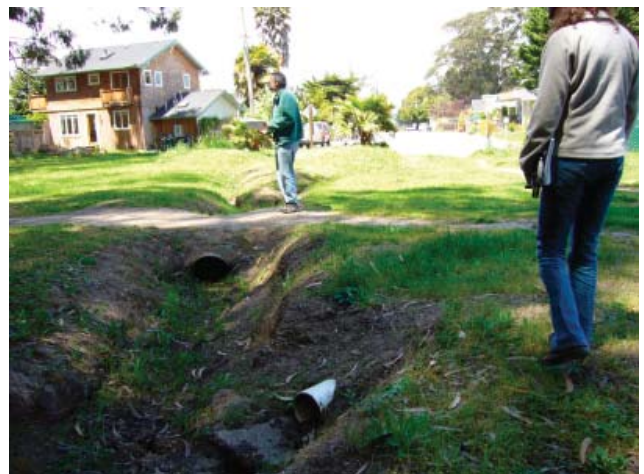
Drainage is coming from off site locations resulting in ditches that cut through the field in several locations and then flow into the drainage channel that surrounds the D. A. Porath Sanitation Facility (Figure 70).

Existing Drainage Channel (Figure 70)

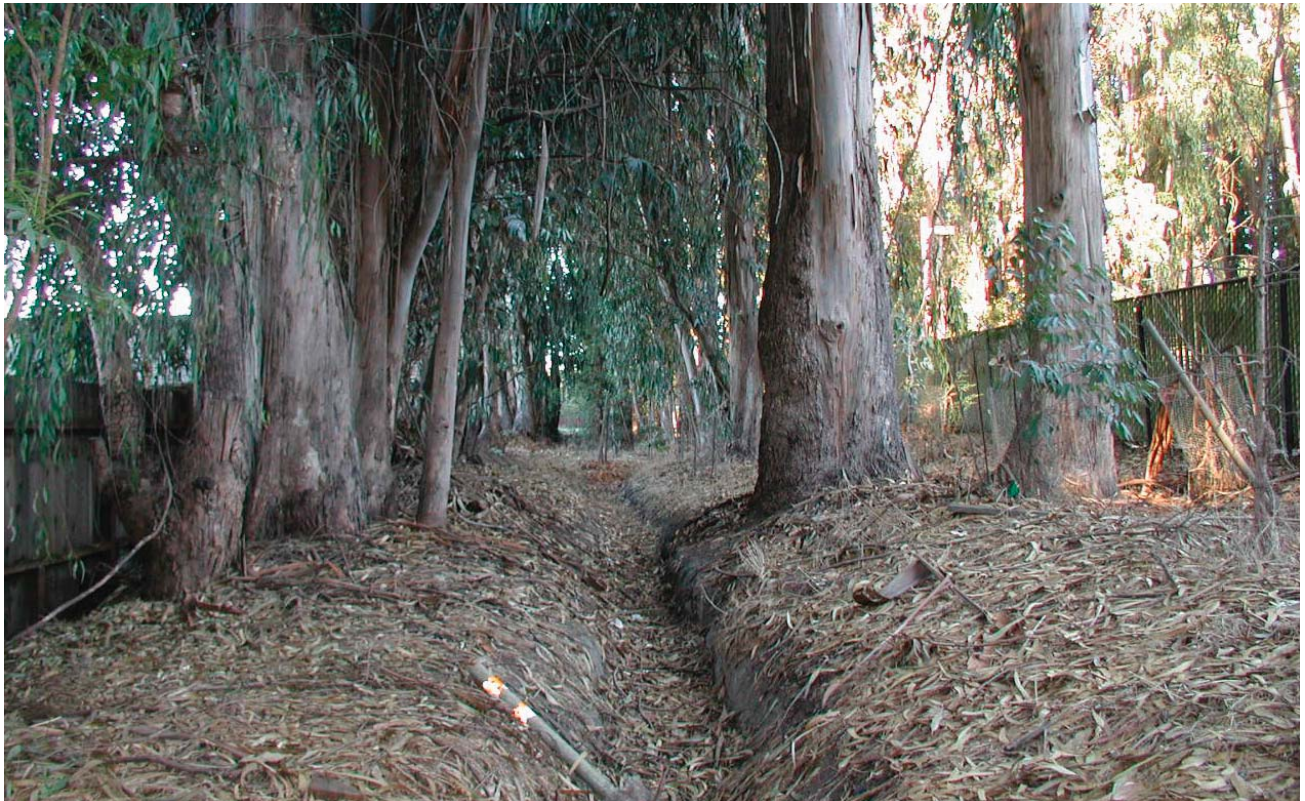
This area provides essential windbreak, sheltering the primary roost area from the south easterly winds. These trees are located in a narrow strip between the corp yard of the D. A. Porath Sanitation Facility and the property line. Several of the trees have overhanging branches onto the private properties directly to the southwest that present a safety hazard. A drainage channel runs through the area and empties the runoff into Moran Lake. If improvements are not made, erosion of the ditch will continue and eventually undermine the stability of the already declining forest.

Existing Drainage Channel at Critical Windbreak (Figure 72)

- Stabilize existing drainage channel by shallowing banks to a 3:1 slope where possible and installing erosion control blanket, if necessary. Refer to Figure 73.
- Selective and minimal drop-crotch pruning of branches that pose a risk to the neighboring private properties.
- Remove dead coast redwood trees and other recently planted dead or dying plants (Figure 71).
- Plant new trees where there are opportunities. Refer to Figure 75 for approximate locations and species.
- Do not remove existing trees until the replacement trees have reached a height of 50 feet in order to maintain a solid windbreak.
- Exotic understory nectar species shall be controlled and selectively removed as

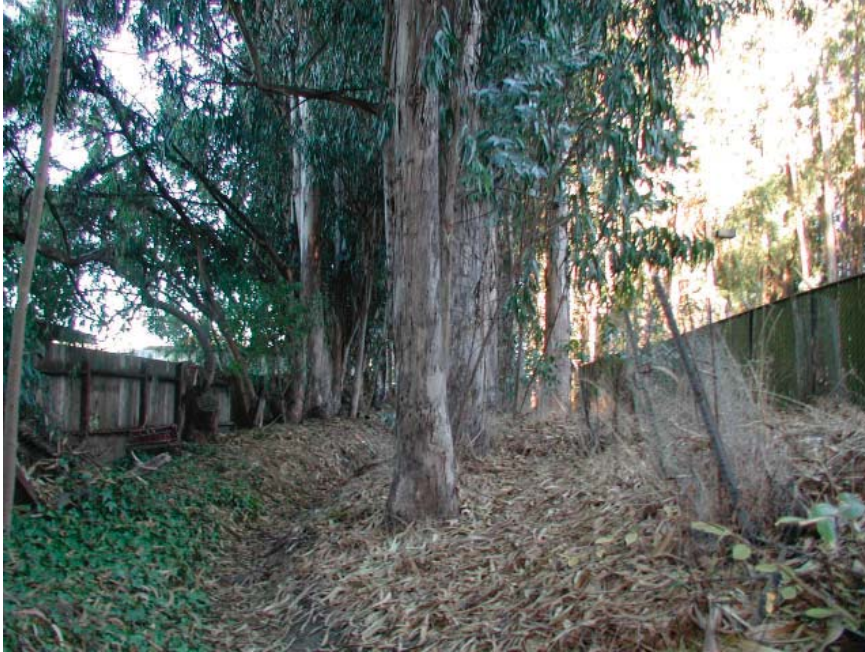
The health of these trees is declining and in order to maintain the essential windbreak for the butterfly habitat a tree replacement program should be started. There is evidence that this was attempted in the past. There are several coast redwoods that have been planted sometime in the last several years, but they have all died. It doesn't appear that there was irrigation to the trees which could be the reason for failure.

Existing Conditions at Critical Windbreak (Before) (Figure 74)

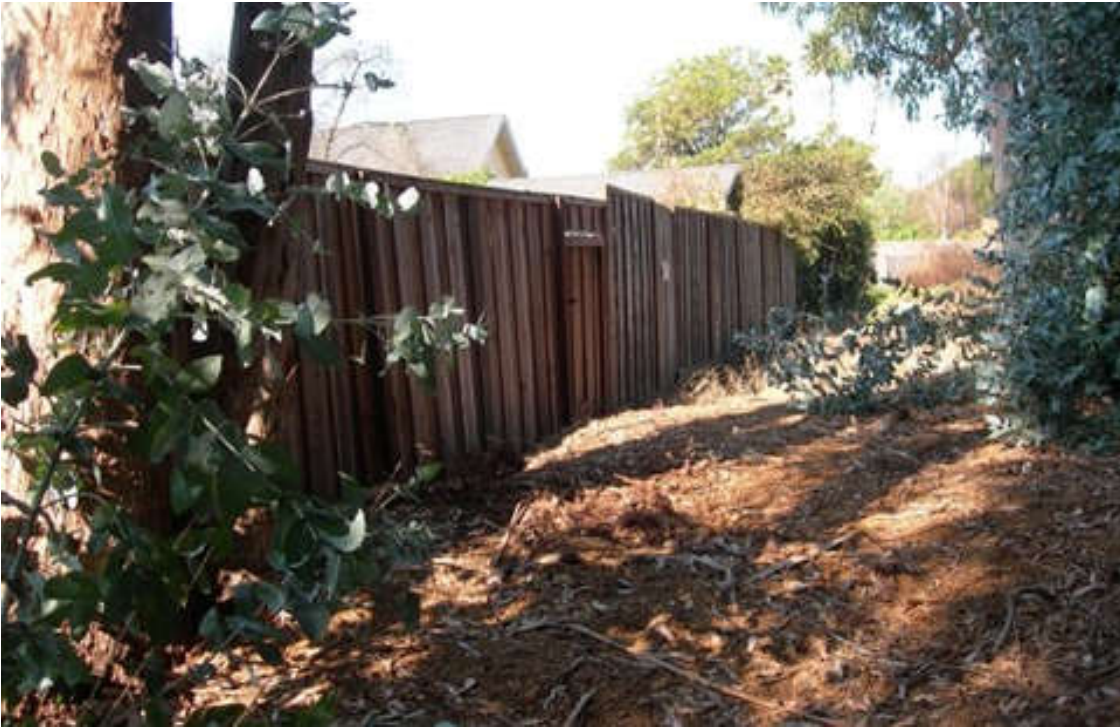
**Photograph 1.** Gap of trees and wind protection along the southern boundary of the Sanitation facility. Plant with red ironbark or blue gum eucalyptus (*sideroxylon* or *globulous*) trees.

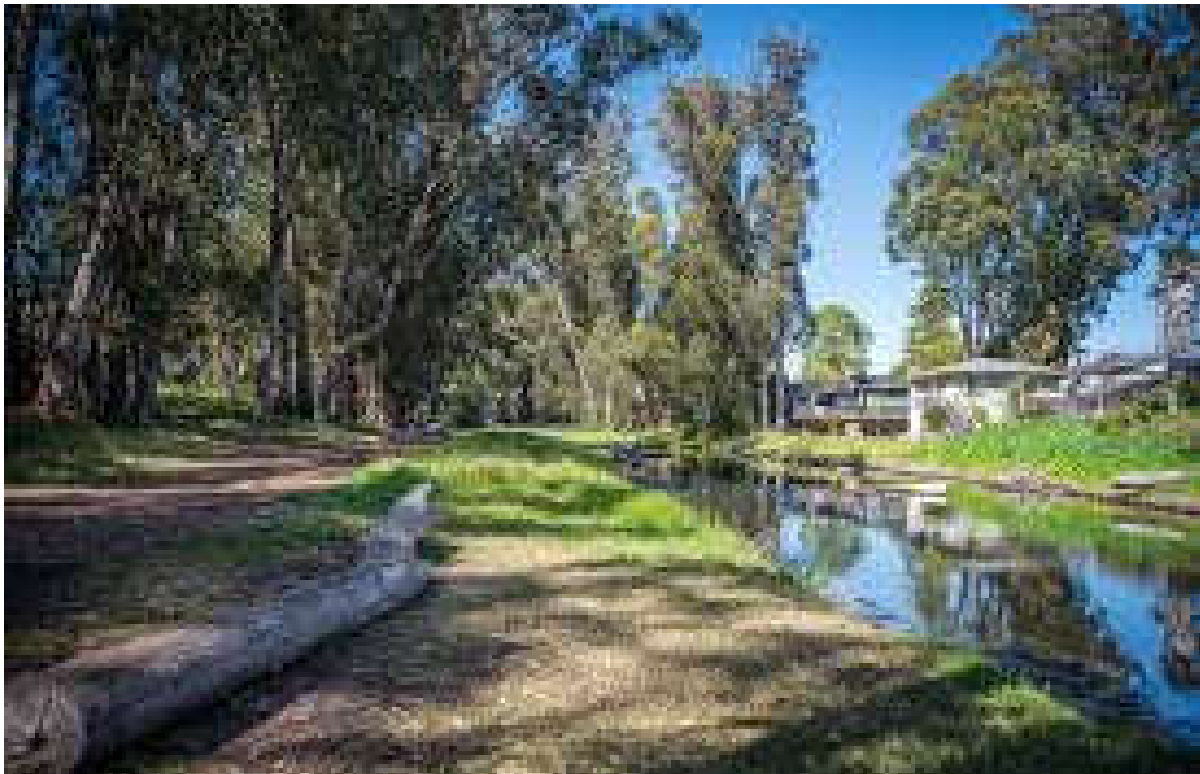
**Photograph 6.** View of the open sunny area to be planted with nectaring plants, to the right of the creek.

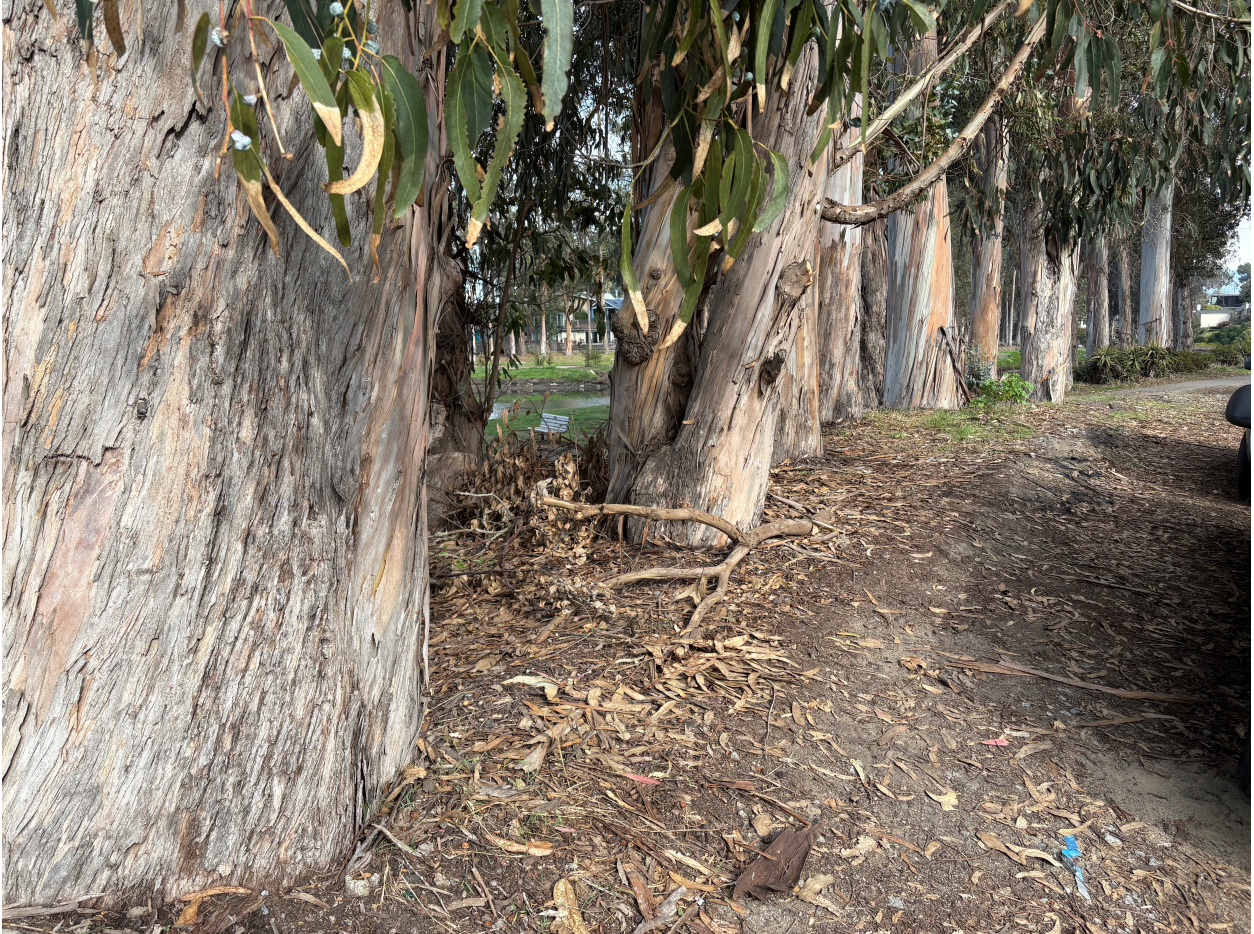
### C1: Buried root collar and codominant stems

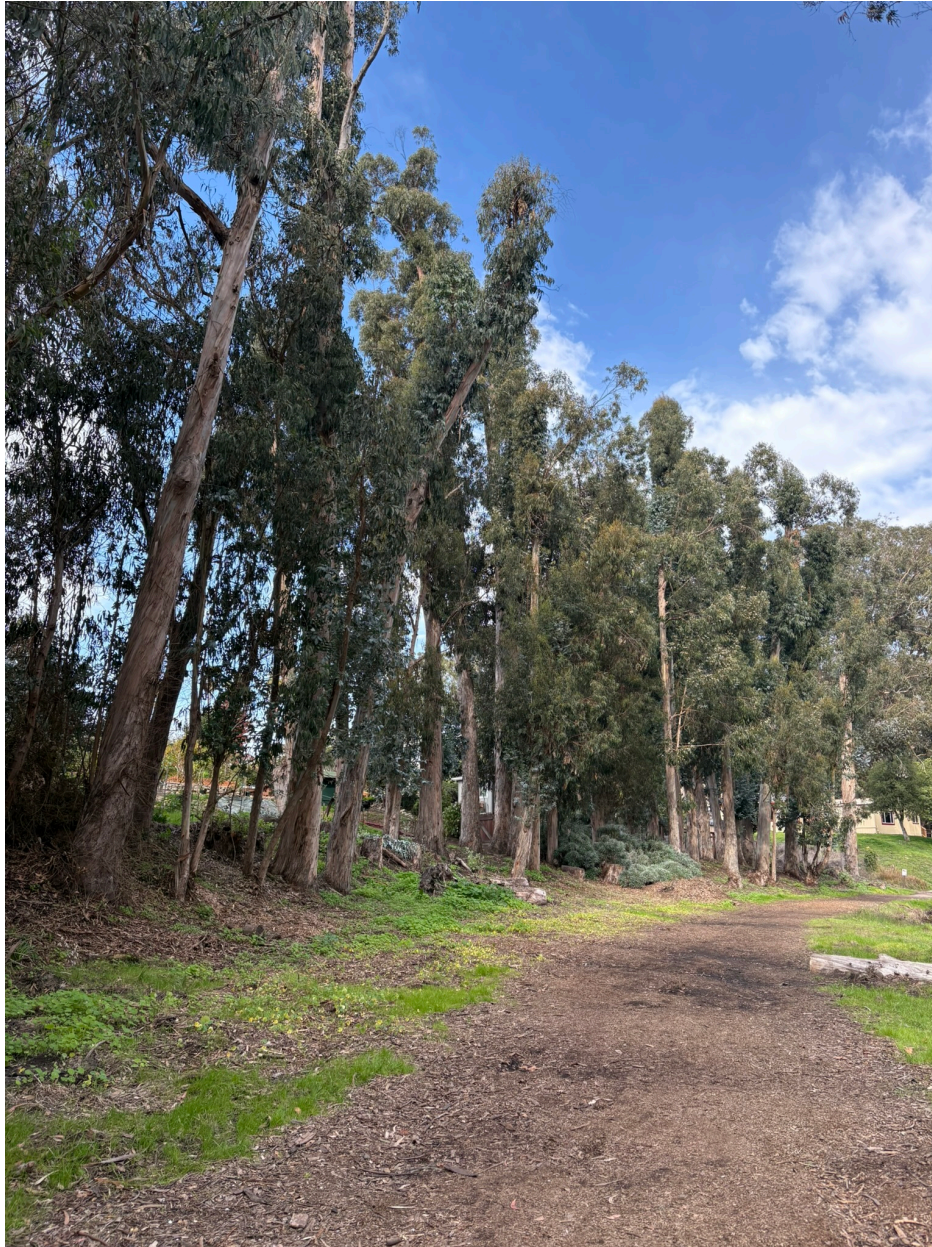
## C2: Topped trees area B and C

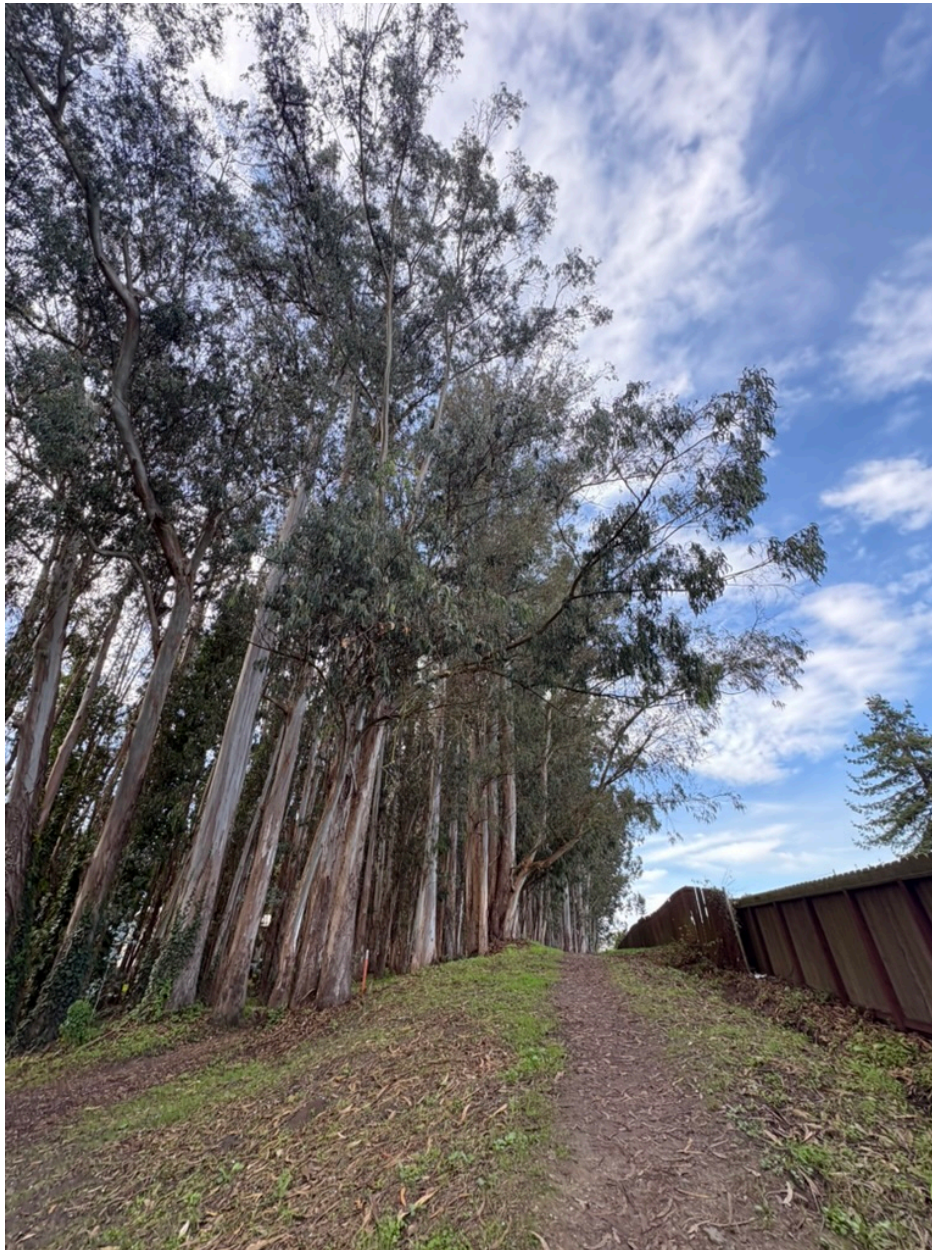
### **C3: Edge trees along the F boundary**

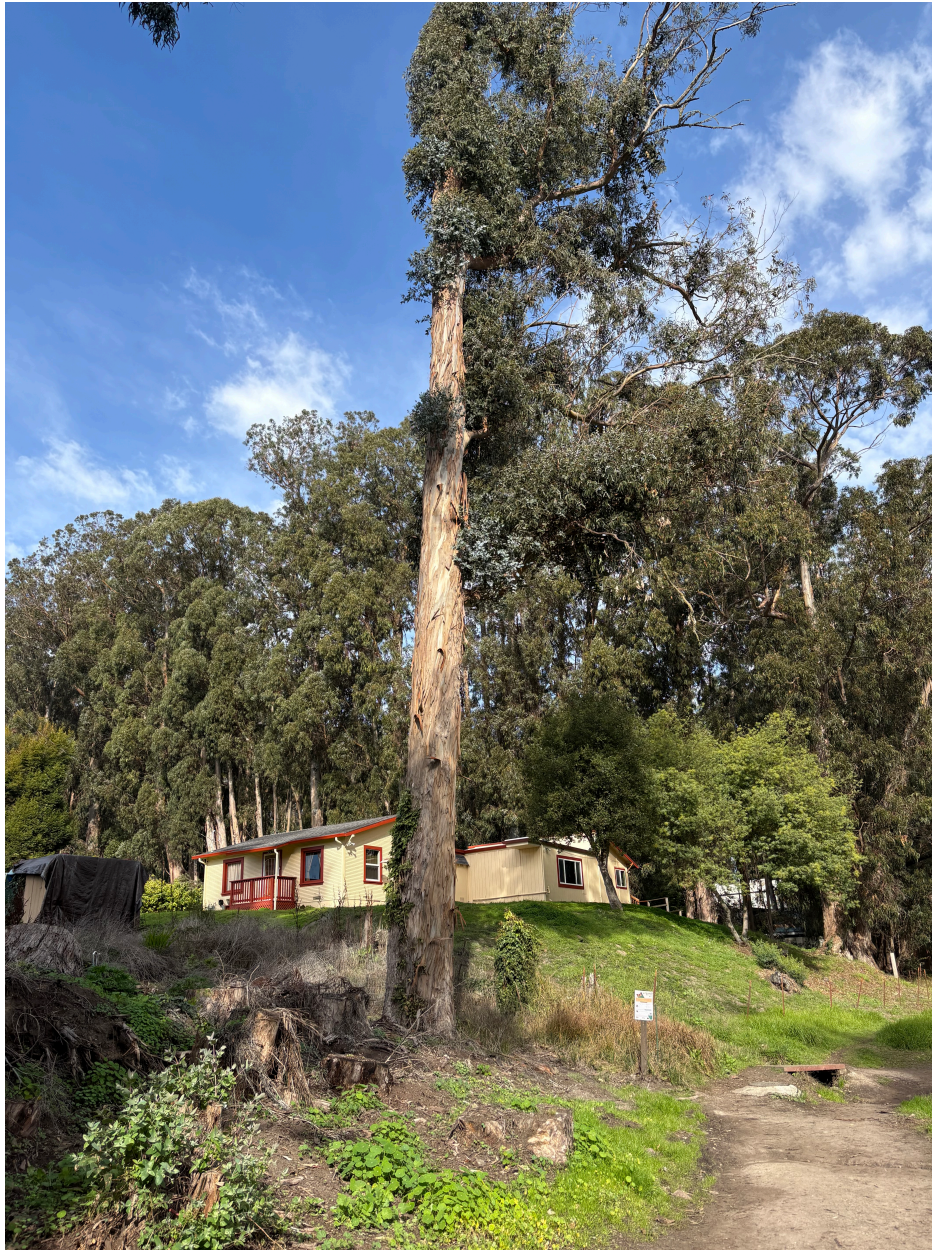
## C4: Lone tree #262 remaining in Area C
